DYNAMIC SEALS FOR ADVANCED HYDRAULIC SYSTEMS

Robert B. Olsen
Vought Corporation
P.O. Box 225907
Dallas, Texas 75265

August 1981

Final Report for Period July 1978 - March 1981

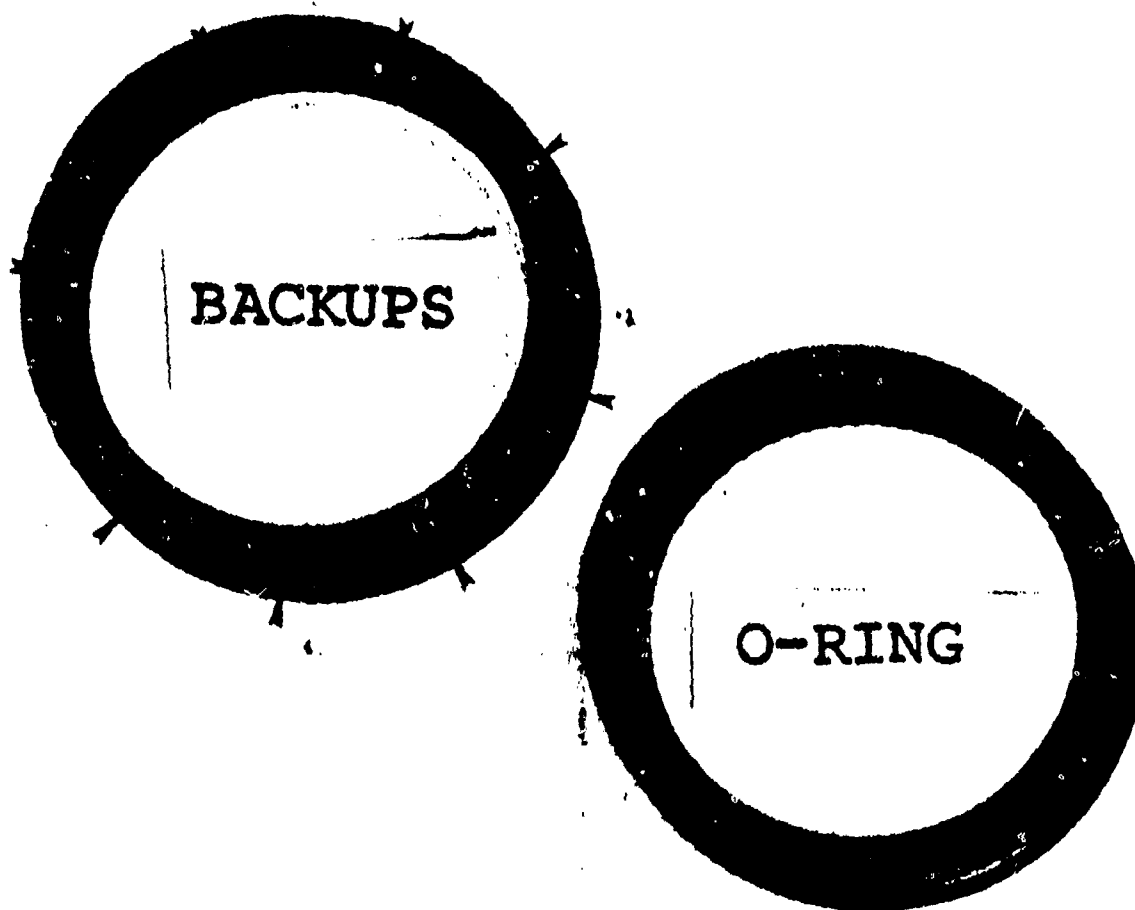
B19-8R-BS

RESULTS: See Figure 49. The TF830-214-1 (outer) backup had minimum wear. The TF830-214-2 (inner) backup flowed around the OD of the outer backup and was pulling away on the ID. The O-ring was nibbled on the ID. The assembly had zero leakage in 1000 cycles. Diametral clearance was .0033.

Figure 49. Candidate B19 After Backup Screening Test. Two stage backup with reduced OD polyimide outer backup; Tetralon 720 inner backup exhibits cold flow over the OD of the center backup (see arrows). O-ring condition is fair.

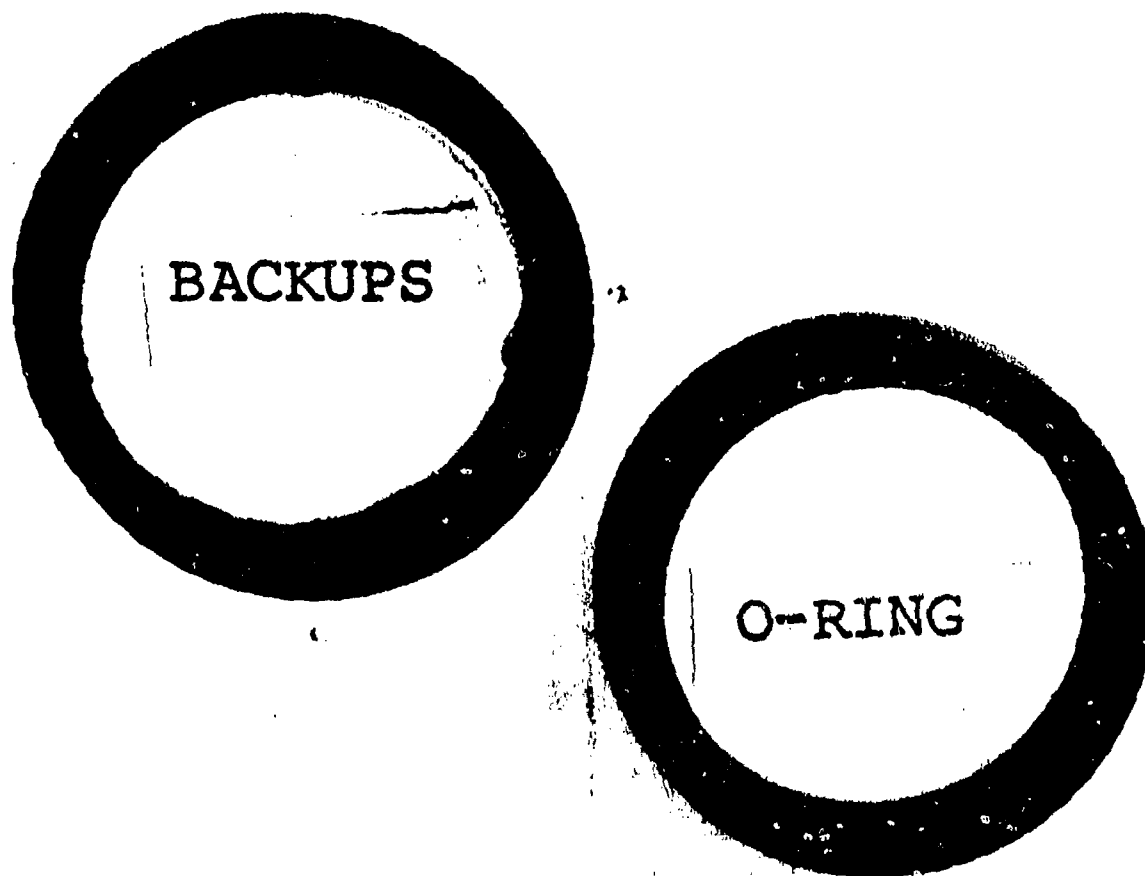
B20-7L-ES

RESULTS: See Figure 50. Both backups exhibited minimum wear. The O-ring was not damaged. The assembly had 3 drops leakage in 1000 cycles. Diametral clearance was .0028.

Figure 50. Candidate B20 After Backup Screening Test.
Two stage backup of spiral backups. O-ring condition is
excellent.

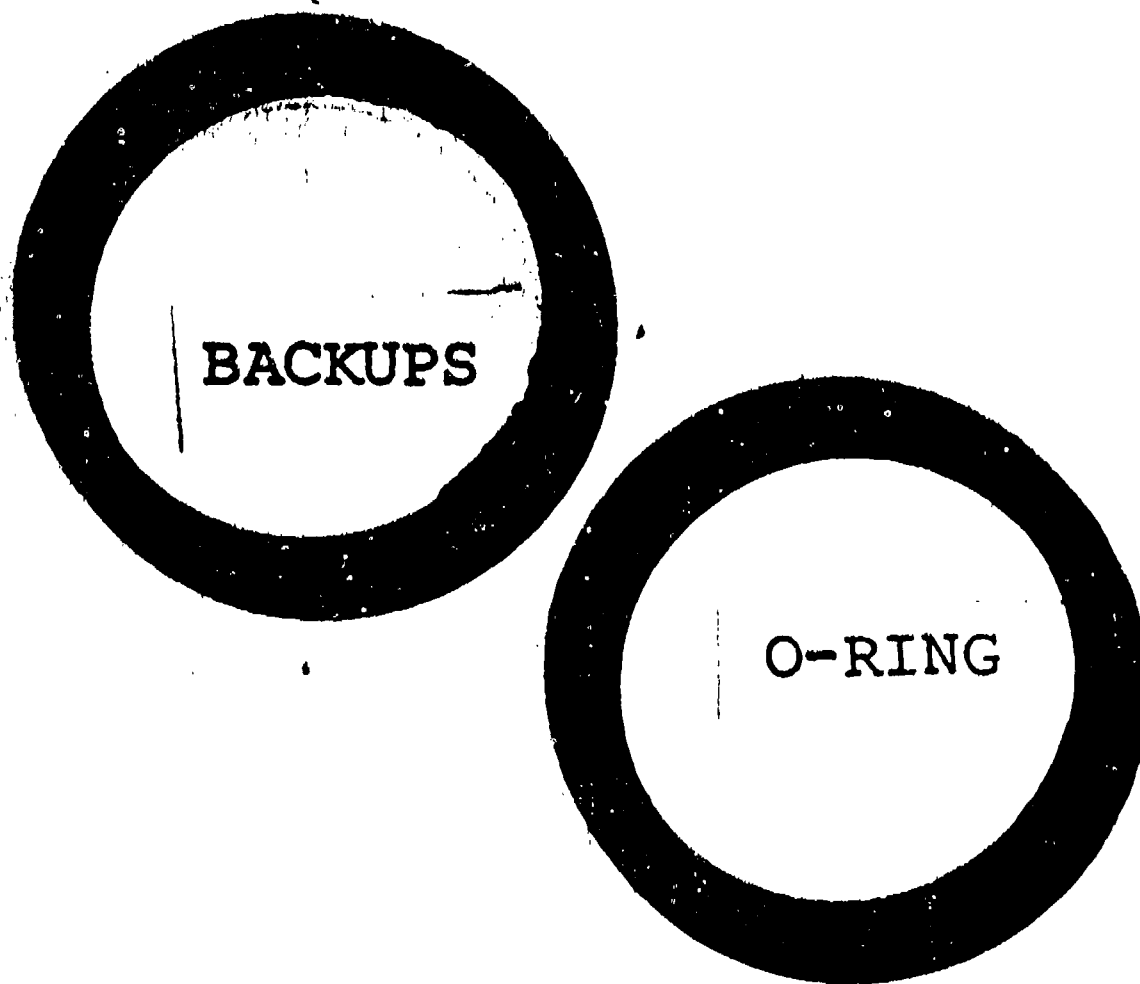
B2C-4R-SS

This candidate was retested for 3.30×10^6 cycles. See Figure 51. The O-ring had some abrasion on the ID. The backups exhibited minimum wear. Total leakage was 3 ml. Diametral clearance was .0031.

Figure 51. Candidate B20 After 3.30×10^6 Endurance Cycles with No Impulse Testing. O-ring condition is good. Two stage backups are fused together.

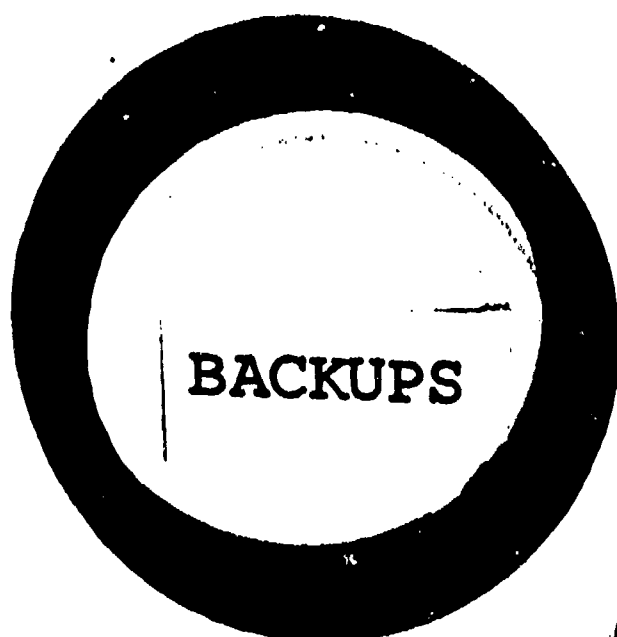
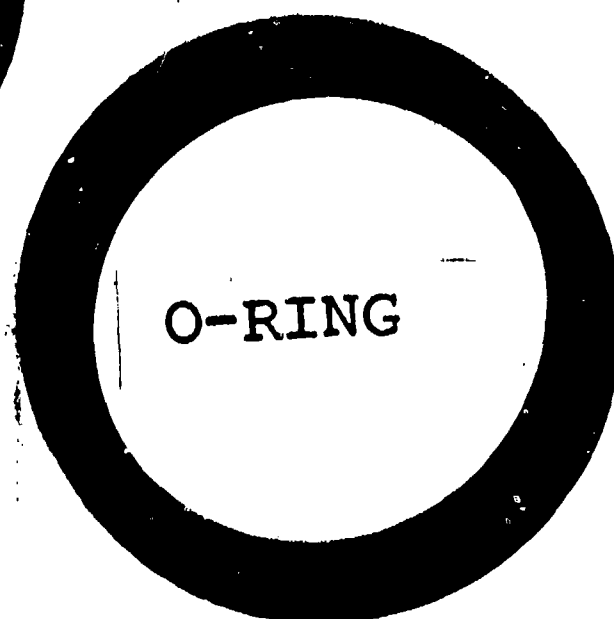
B22-7R-SS

This candidate was retested for 3.30×10^6 cycles. See Figure 55. The O-ring was undamaged. Minimum backup wear occurred. Total leakage was 1 drop. Diametral clearance was .0030.

Figure 55. Candidate B22 After 3.30×10^6 Endurance Cycles With No Impulse Testing. O-ring condition is excellent.

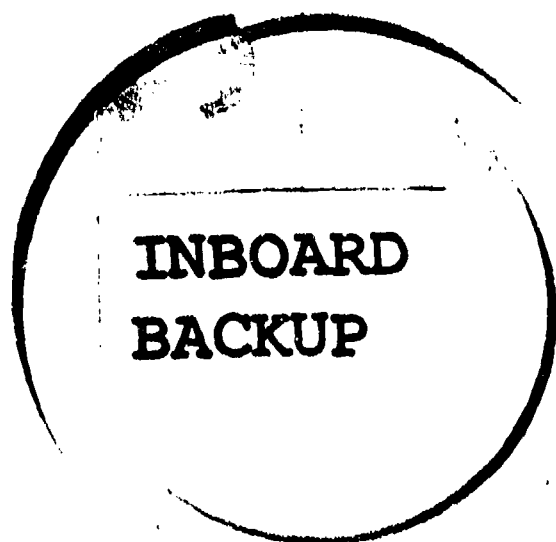
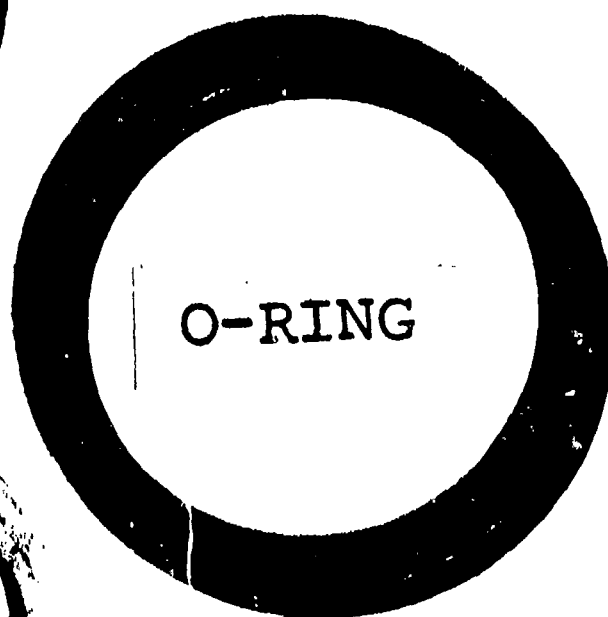
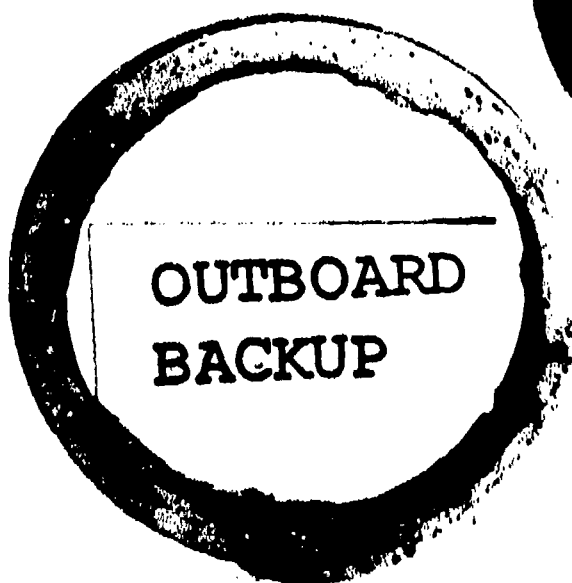
B1-2L-SS

RESULTS: See Figure 57. The rod seal used exclusively with the scrapers during screening tests of scrapers has been an M83461/1-214 O-ring with MS28774-214 backups. These seals were not considered to be part of the backup ring candidates due to the fact they operated on the contaminated rod end with the crew tester assembly. The performance of these backups should be considered to some extent due to the quantities involved. Eight MS28774 backup installations were used in the first set of scraper screening tests. Fourteen installations were made for the screening tests on additional scraper candidates. The average diametral clearance of the bore to rod on the first tests was .0039, but the seals were not impulse tested. No rod seal failures occurred. The tests on additional scraper candidates included 0-4500 impulse testing to aid in evaluation of the backup candidates. Eight rod seal failures with MS28774 backups occurred. Average diametral clearance was .0041. Failures

Figure 57. Typical Appearance of MS28774-214 Backups and M83461/1 O-ring Used With Scraper Candidates - No Impulse Testing. O-ring condition was good for 6 of 8 seals.

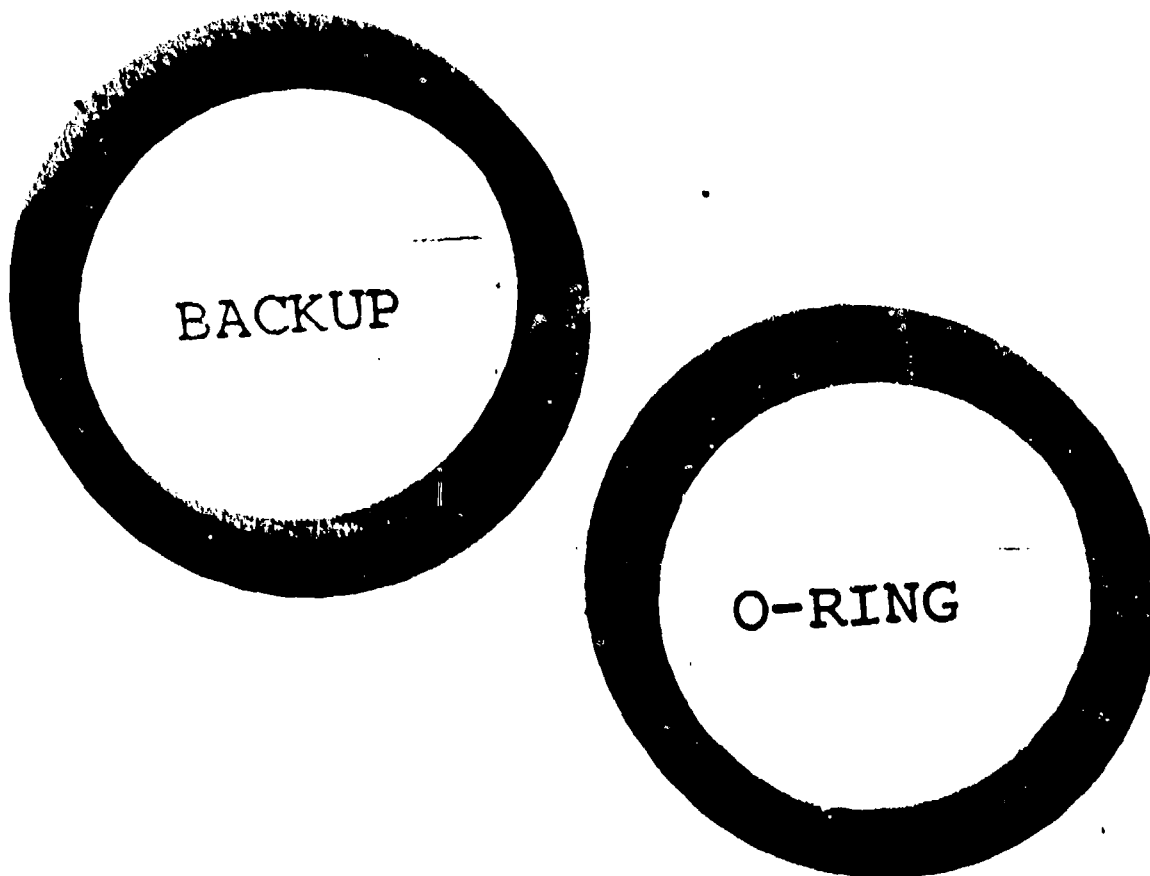
B27-7R-AS

Figure 63. Candidate B27 Backup After Additional Screening Test.
O-ring failed due to extrusion on the ID after 1.53×10^6 endurance
plus 66000 impulse cycles.

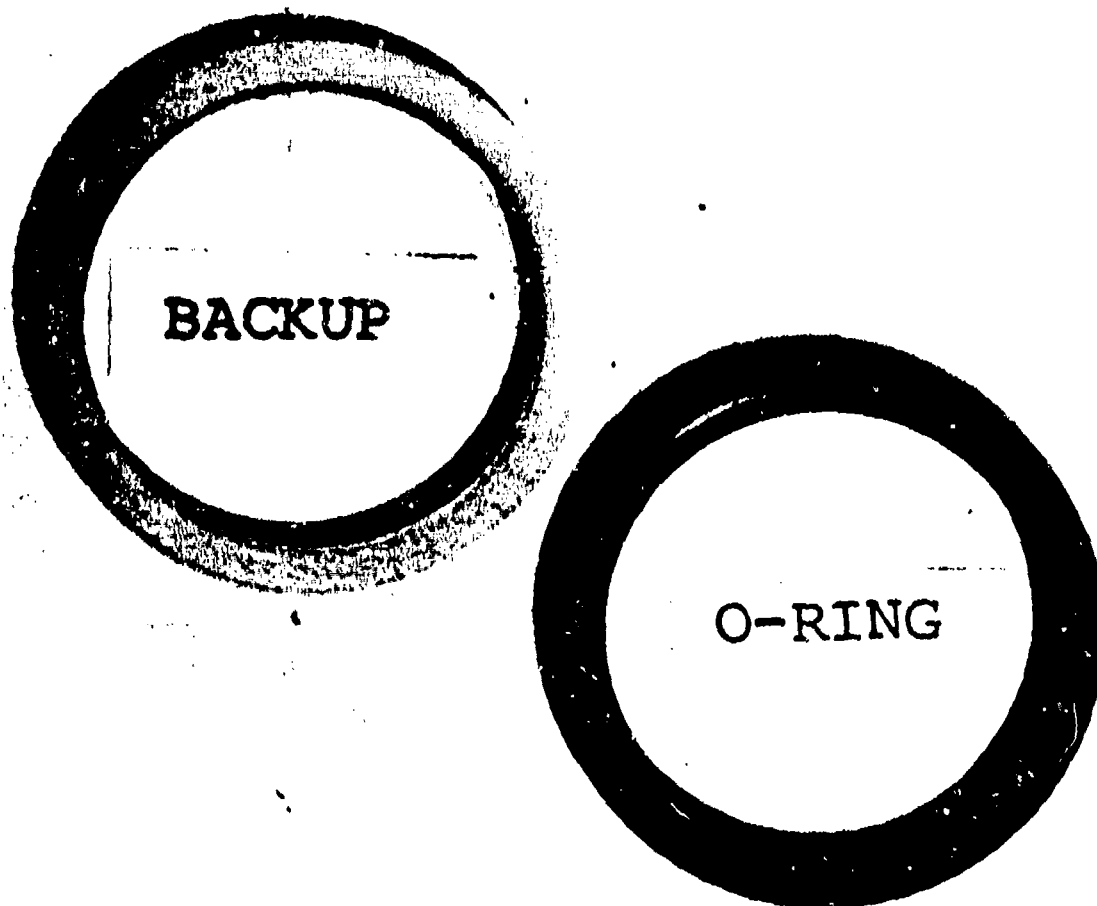
B28-1R-AS

Figure 64. Candidate B28 Backup After Additional Screening Test. O-ring is in good condition.

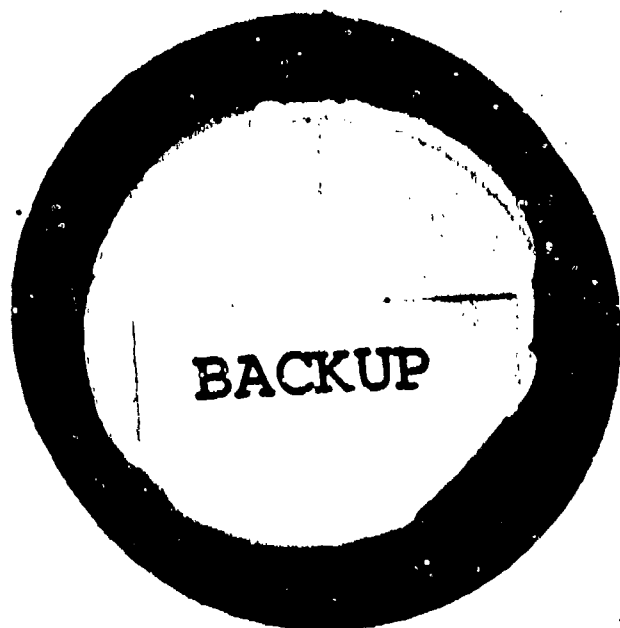
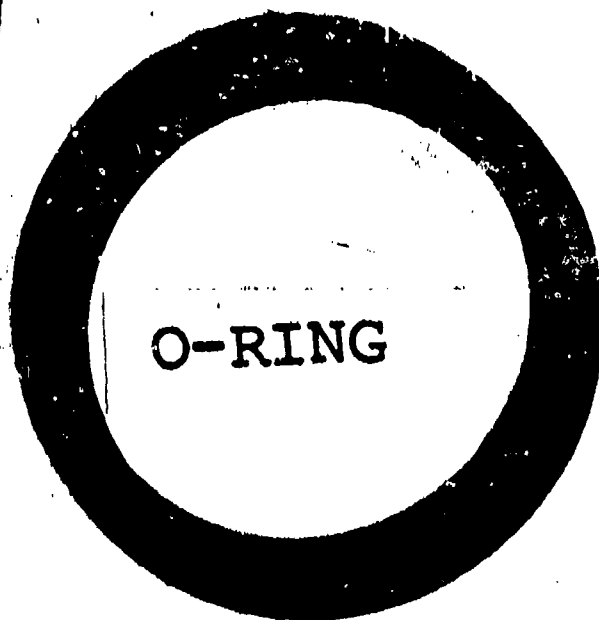
B29-8R-AS

Figure 65. Candidate B29 Backup After Additional Screening Test.
O-ring is in good condition.

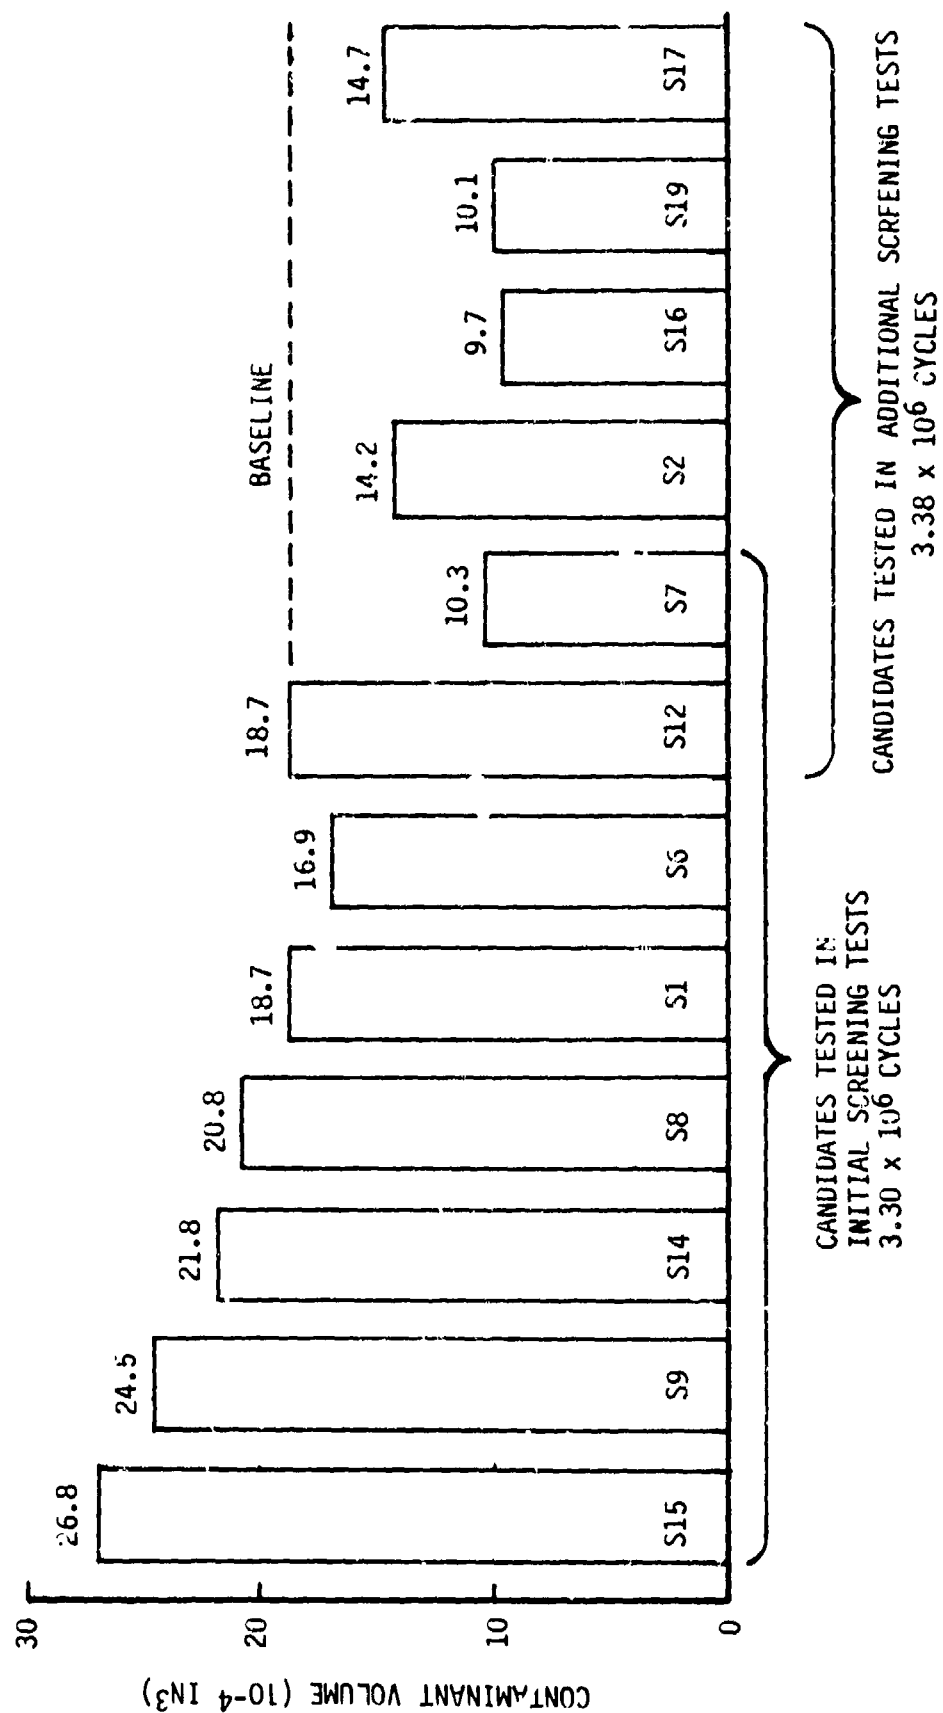
Figure 71 shows the relative performance of the scrapers which were part of the first and second scraper screening tests. The figure shows that all of the new or improved scrapers transmitted less contaminant than the average value of the contaminant transmitted by MS28776M9 for the two tests.

Figure 71. Results of Scraper Screening Tests. The new and improved designs in the additional screening tests performed better than the baseline.

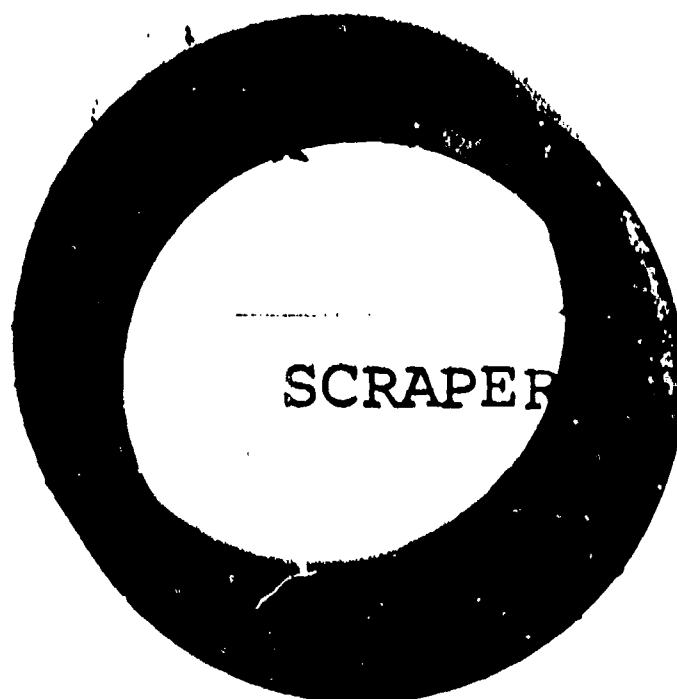
S6-4L-SS

Figure 86. Candidate S6 After Scraper Screening Test.
Bronze cones with elastomer seal.

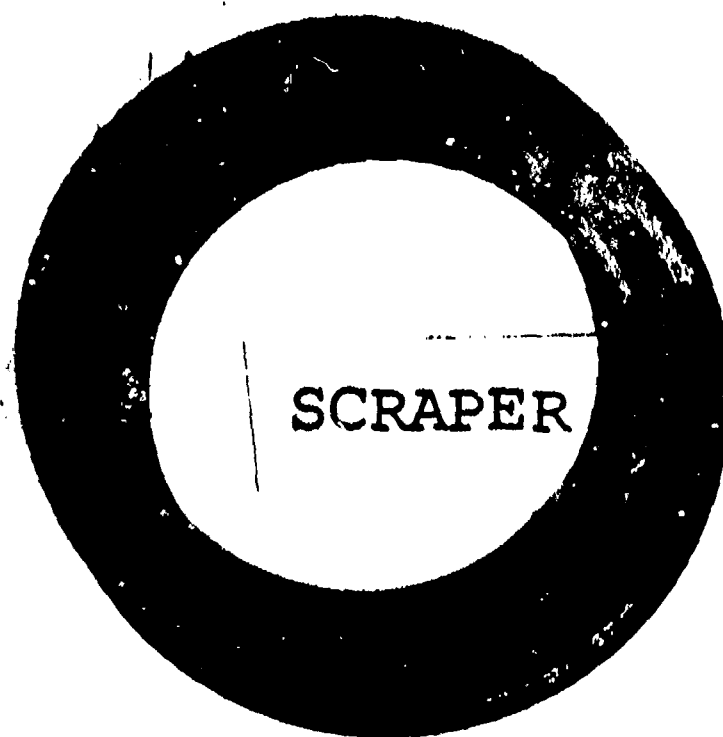
S8-3L-SS

Figure 88. Candidate S8 After Scraper Screening Test.
Molythane material with nitrile O-ring energizer.

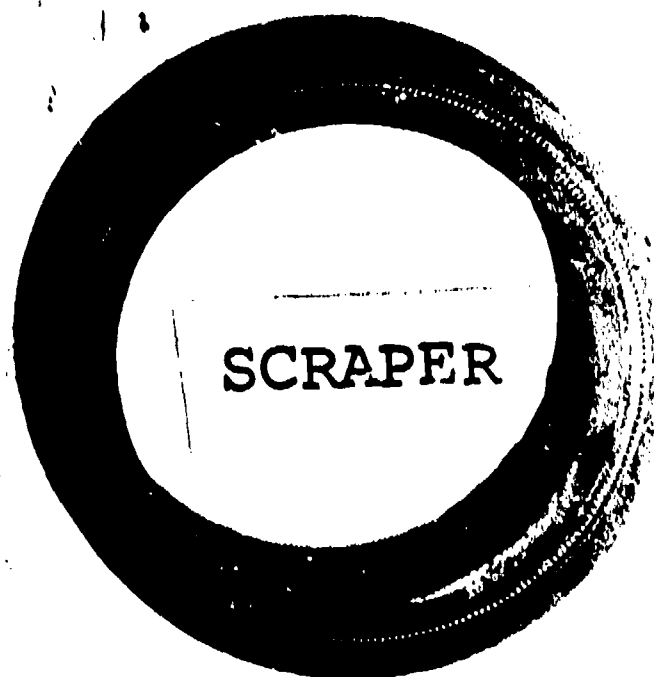
S 9-7L-SS

Figure 89. Candidate S9 After Scraper Screening Test.
Hytrel material with spring energizer.

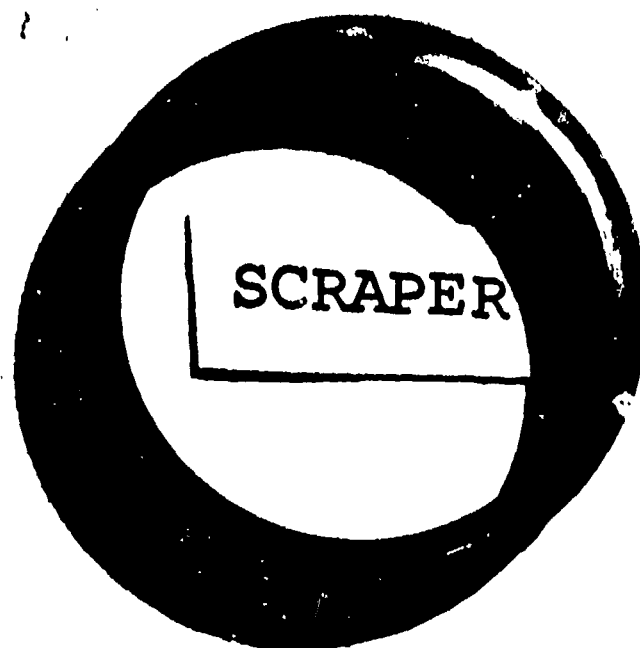
S12-1L-SS

Figure 90. Candidate S12 After Scraper Screening Test.
Baseline MS28776M9 scraper of bronze material.

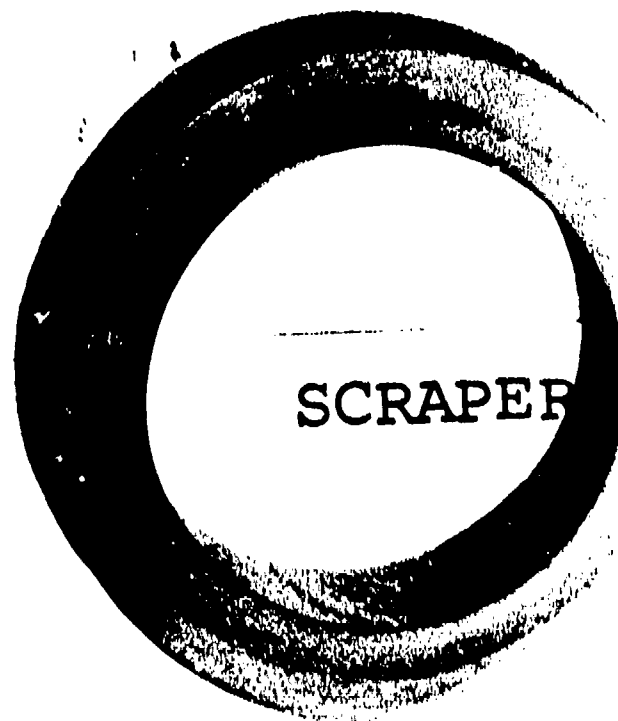
S14-2L-SS

Figure 91. Candidate S14 After Scraper Screening Test.
Polurethane material is NFPA configuration.

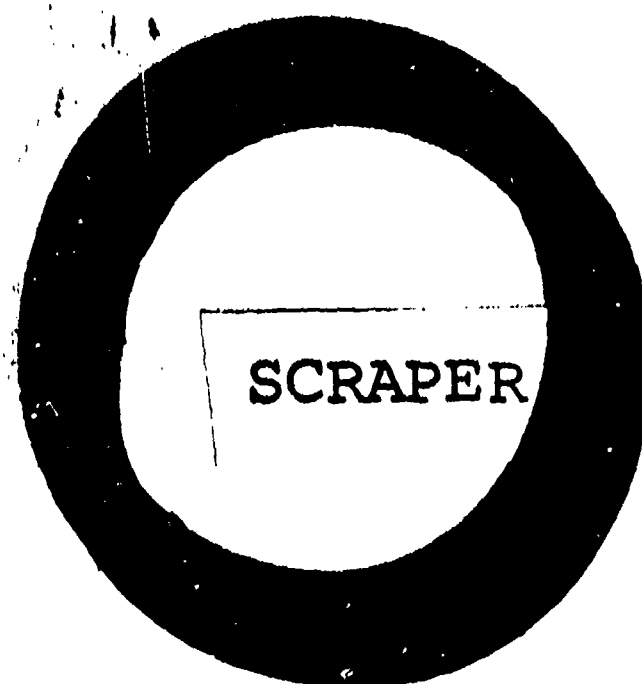
S15-5L-SS

Figure 92. Candidate S15 After Scraper Screening Test.
Damage occurred during removal after test.

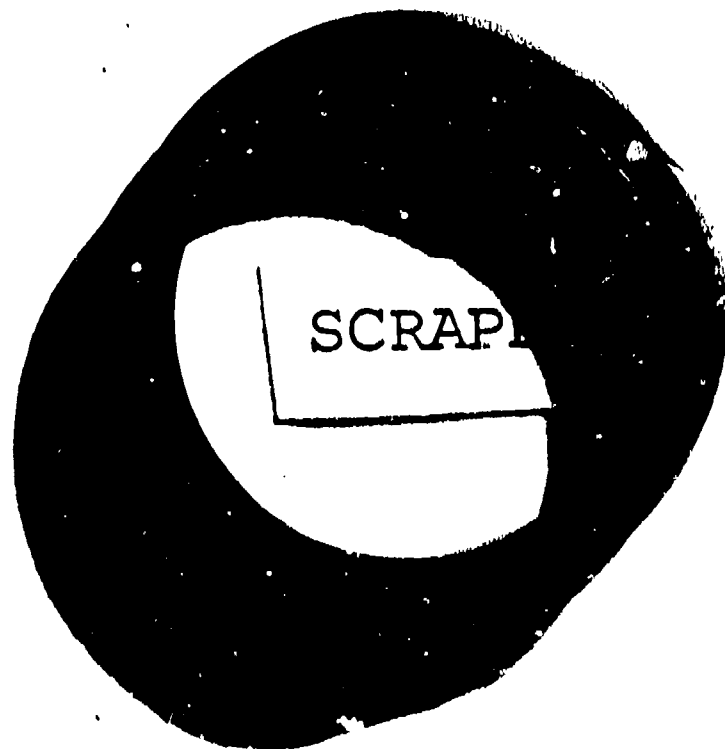
S2-6L-AS

Figure 93. Candidate S2 Scraper After Additional Screening Test.

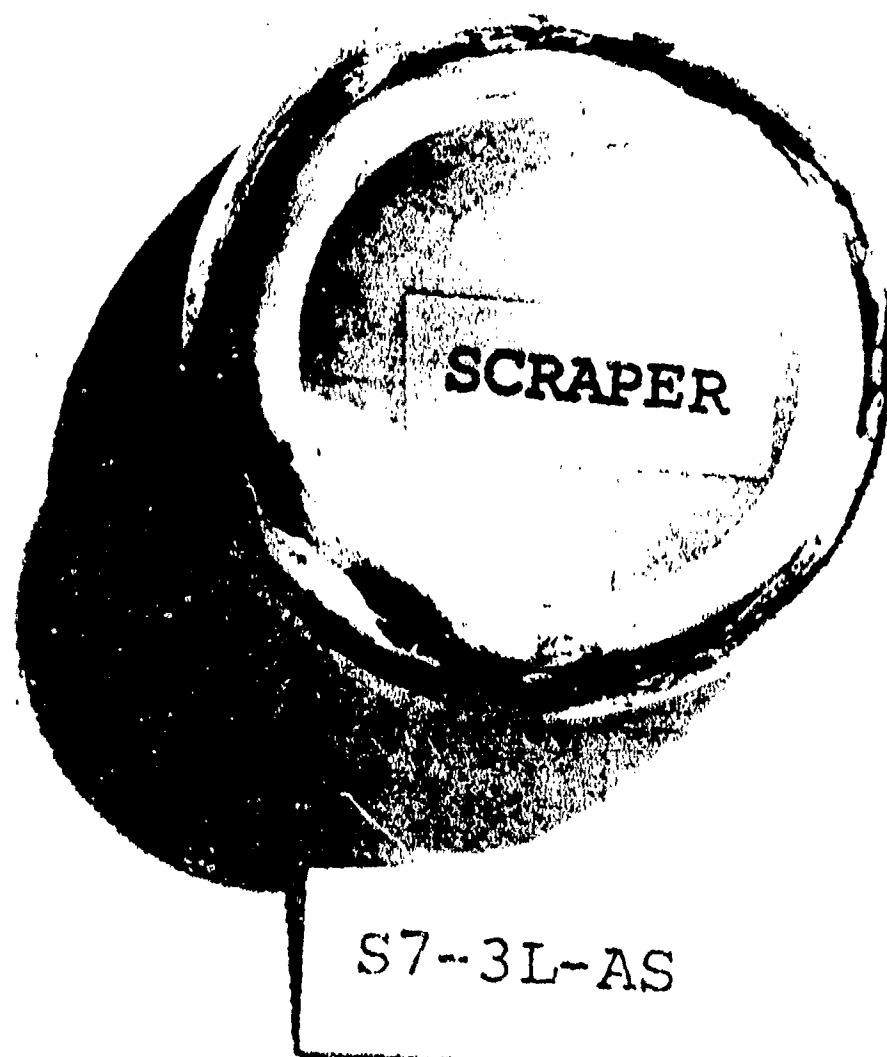
Figure 94. Candidate S7 Scraper After Additional Screening Tests. Damage to OD occurred during removal after test.

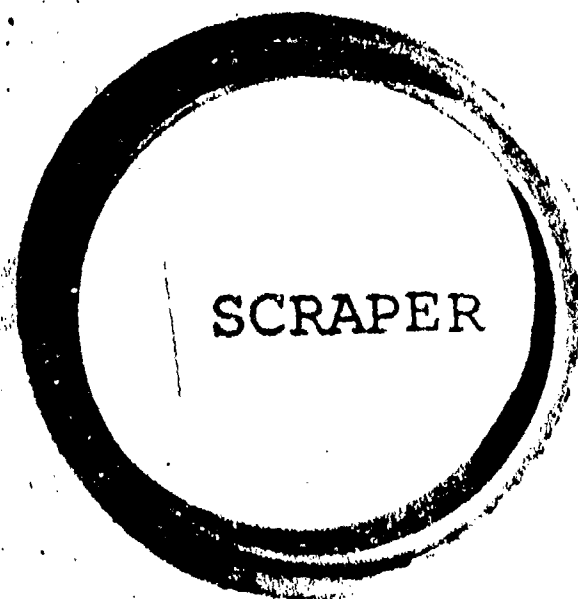
S12-2L-AS

Figure 95. Candidate S12 Scraper After Additional Screening Tests. MS28776M9 was baseline for all scraper tests.

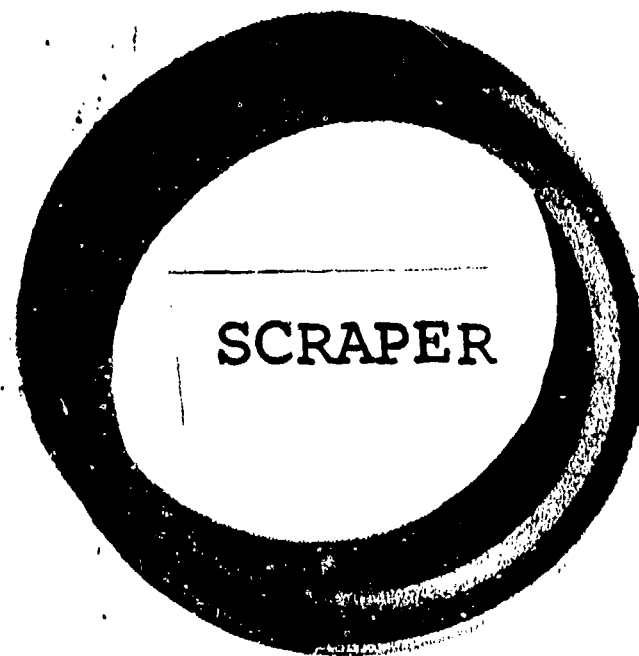
S16-5L-AS

Figure 96. Candidate S16 Scraper After Additional Screening Test.

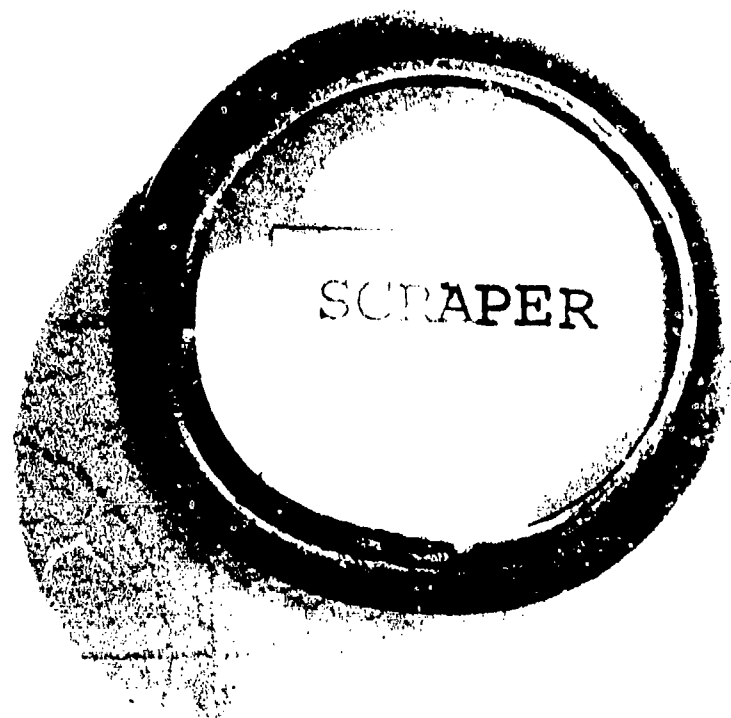
S17-17

Figure 97. Candidate S17 Scraper After Additional Screening Test.

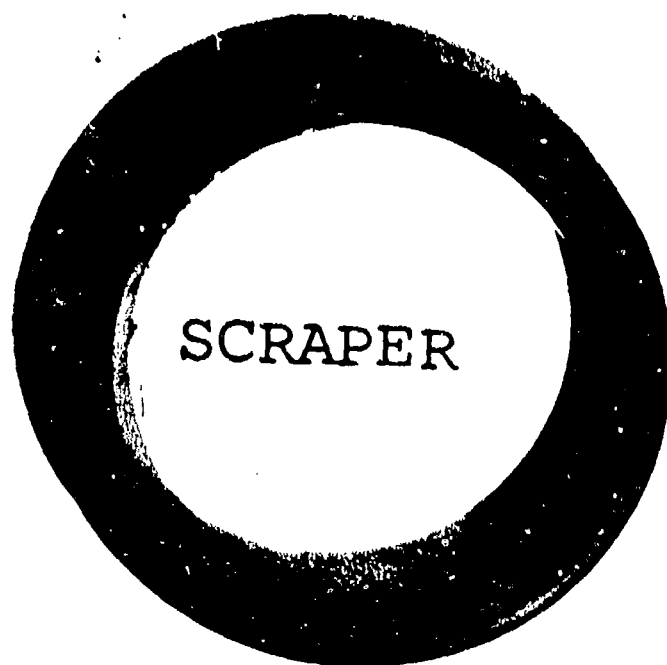
S19-7L-7S

Figure 98. Candidate S19 Scraper After Additional Screening Test.

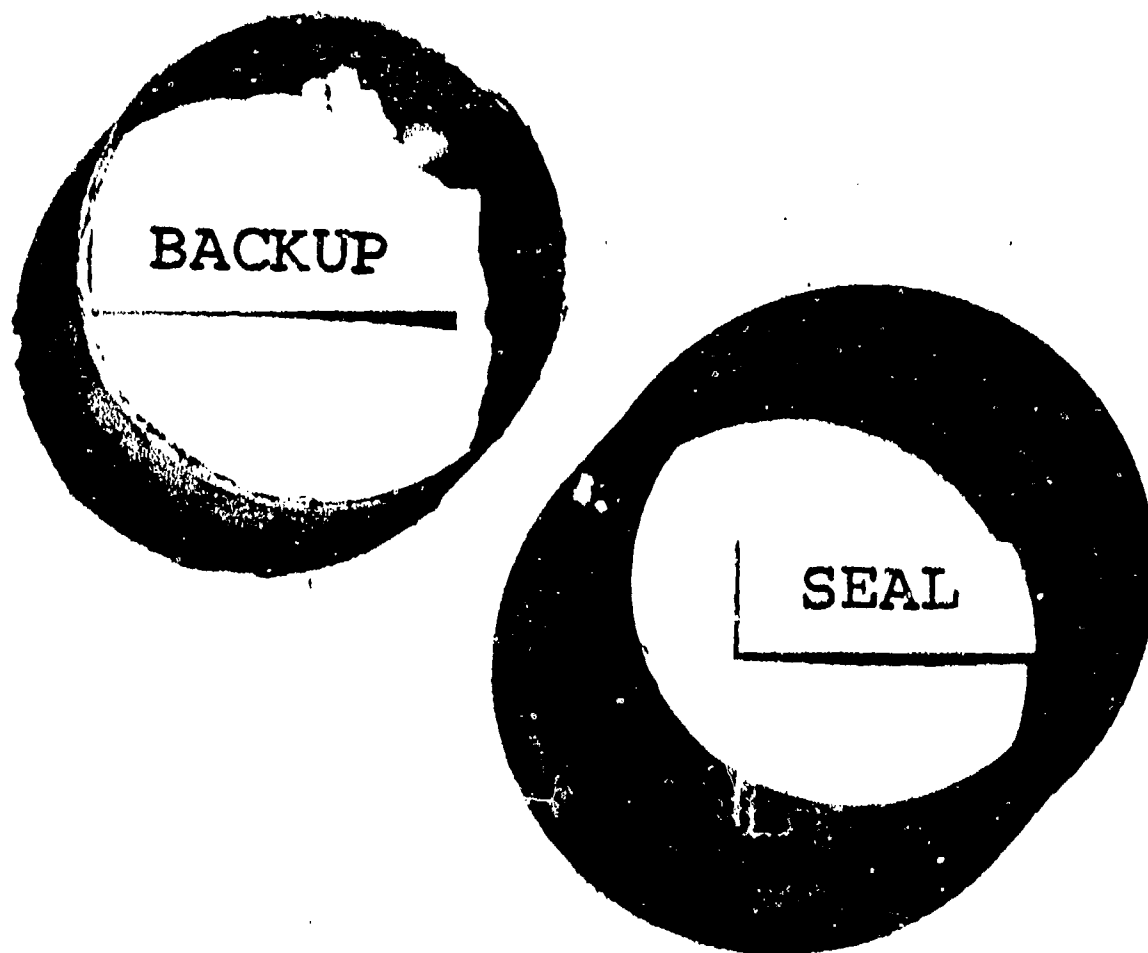
RS13-5R-RS

RESULTS: See Figure 112. The seal and backup were in good condition. The backup exhibited some wear. Leakage was 1 drop static, 1 drop during low temperature, and 1 drop dynamic. The rod had very light wear in the area in contact with the seal.

Figure 112. Candidate RS13 After Single Stage Rod Seal Screening Test. Seal is Dowty 1109 nitrile. Backup is unfilled TFE.

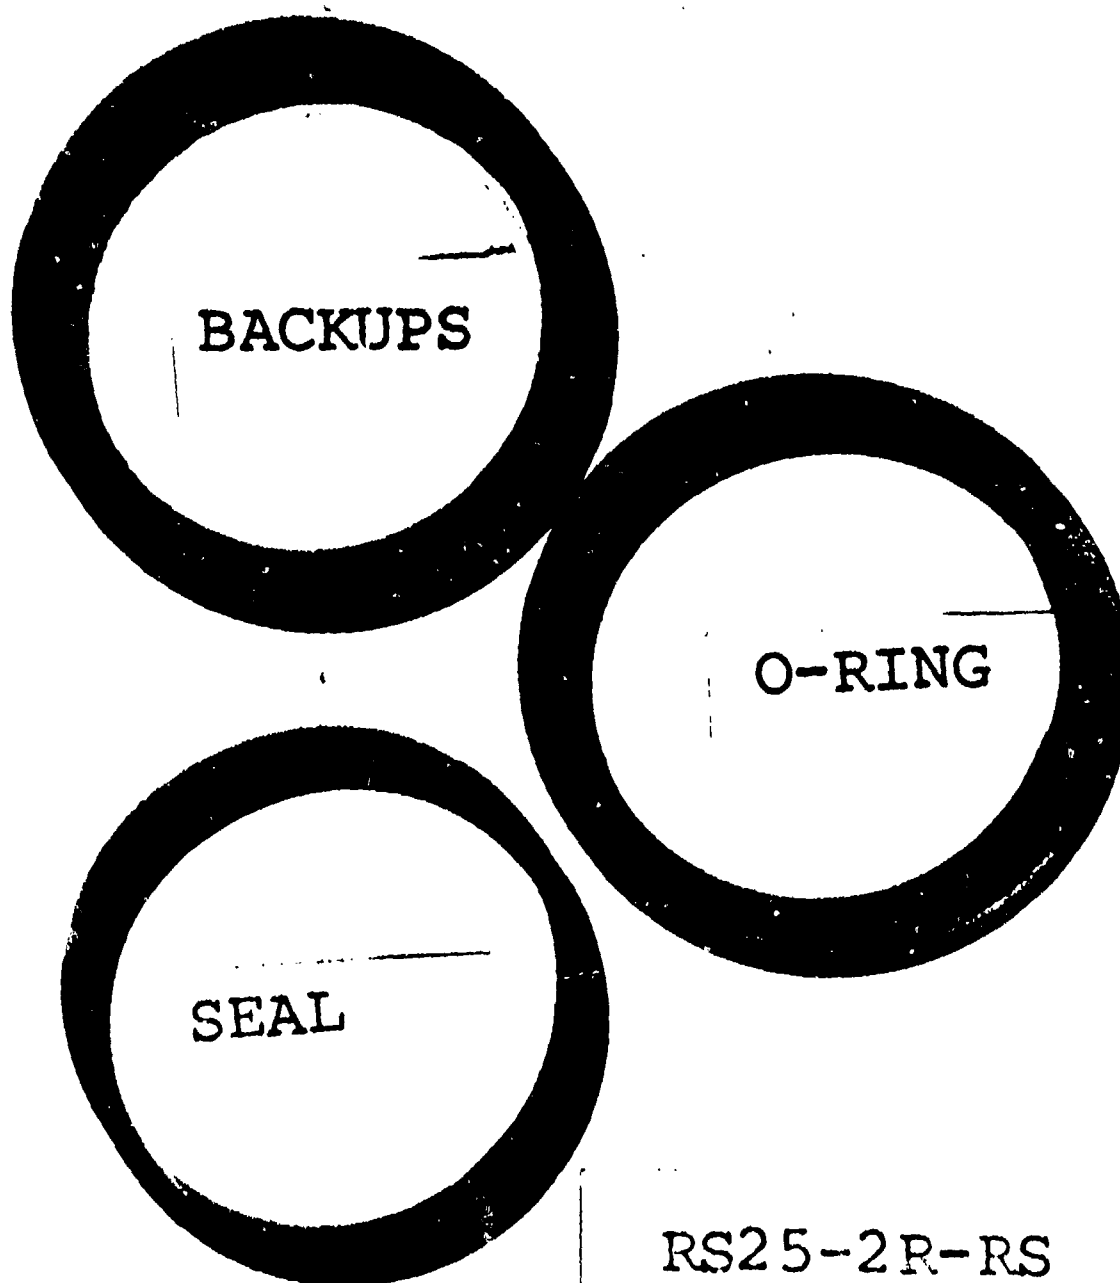
RESULTS: See Figure 116. Seal and backups are in good condition. Static leakage was 2 drops. Low temperature leakage was 2 drops. Dynamic leakage was 5.5 cc. The rod exhibited light wear under the seal in the area contacted during 1, 2 and 10 percent stroke cycling.

Figure 116. Candidate RS25, After Single Stage Rod Seal Screening Test. Seal and backup material is Shamban Code 14.

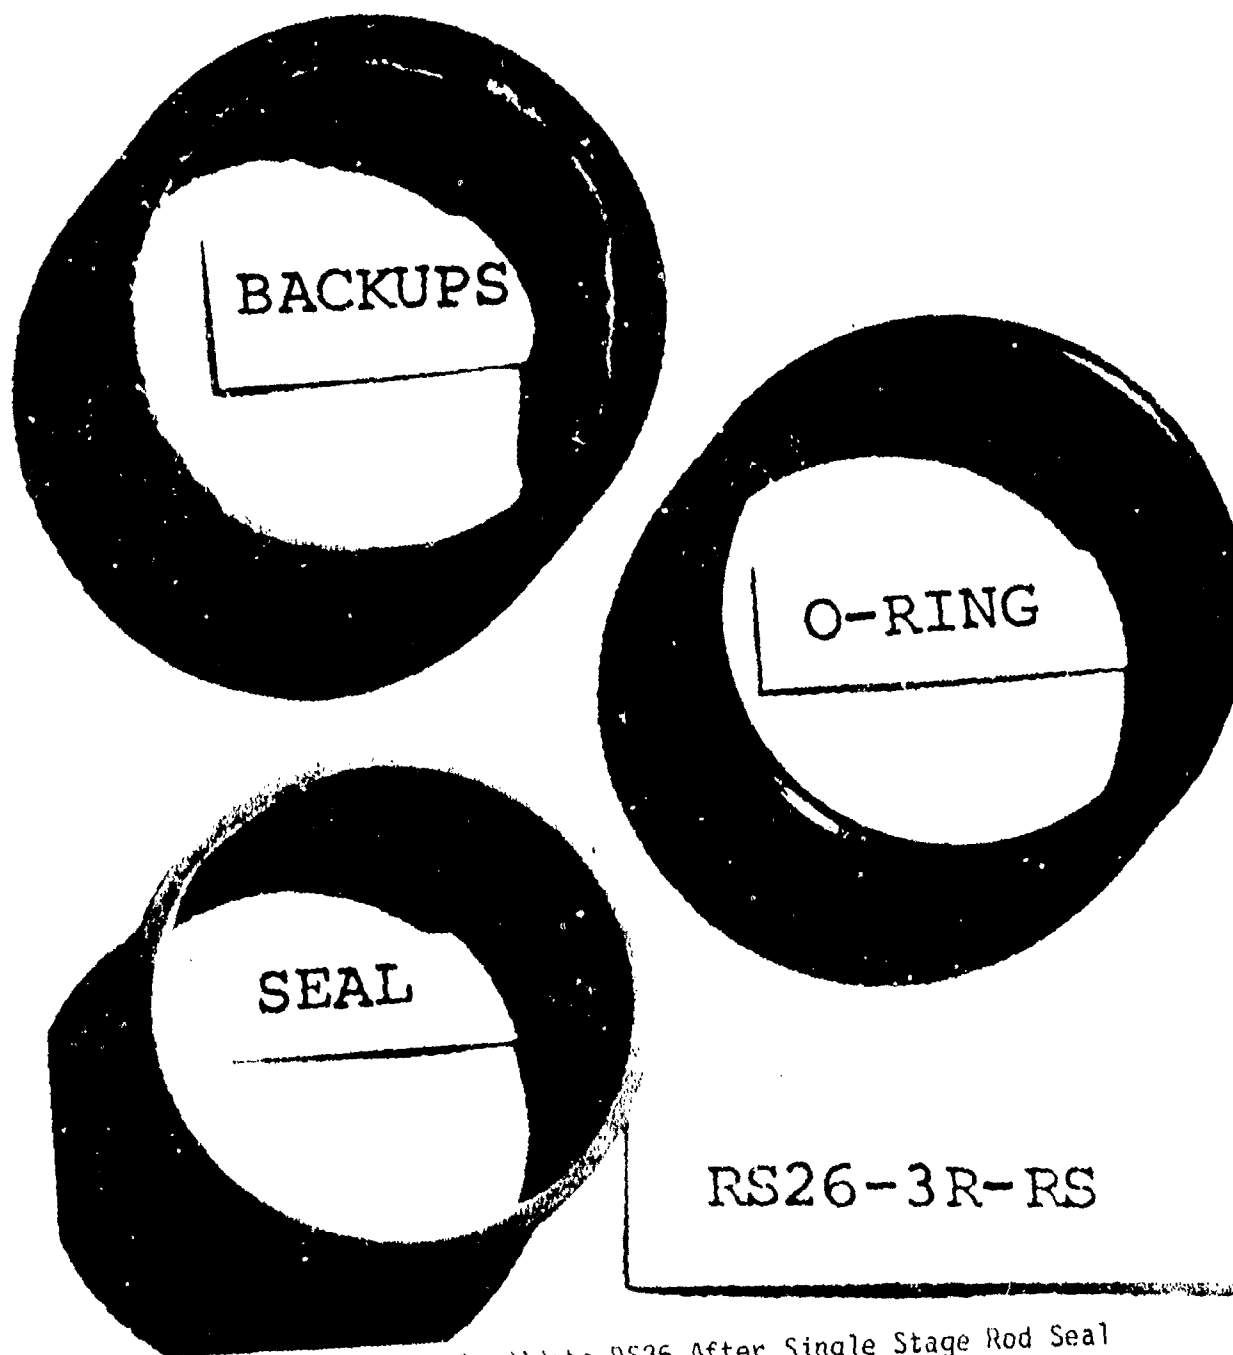
RESULTS: See Figure 117. Seal and backups were in good condition. The outboard backup exhibited some loss of cross section due to extrusion. Static leakage was 1 drop. Low temperature leakage was 2 drops. Dynamic leakage was 2.2 cc. No rod wear occurred due to seal or backups.

Figure 117. Candidate RS26 After Single Stage Rod Seal Screening Test. Seal is Revonoc 6200, backups are Revonoc 18158.

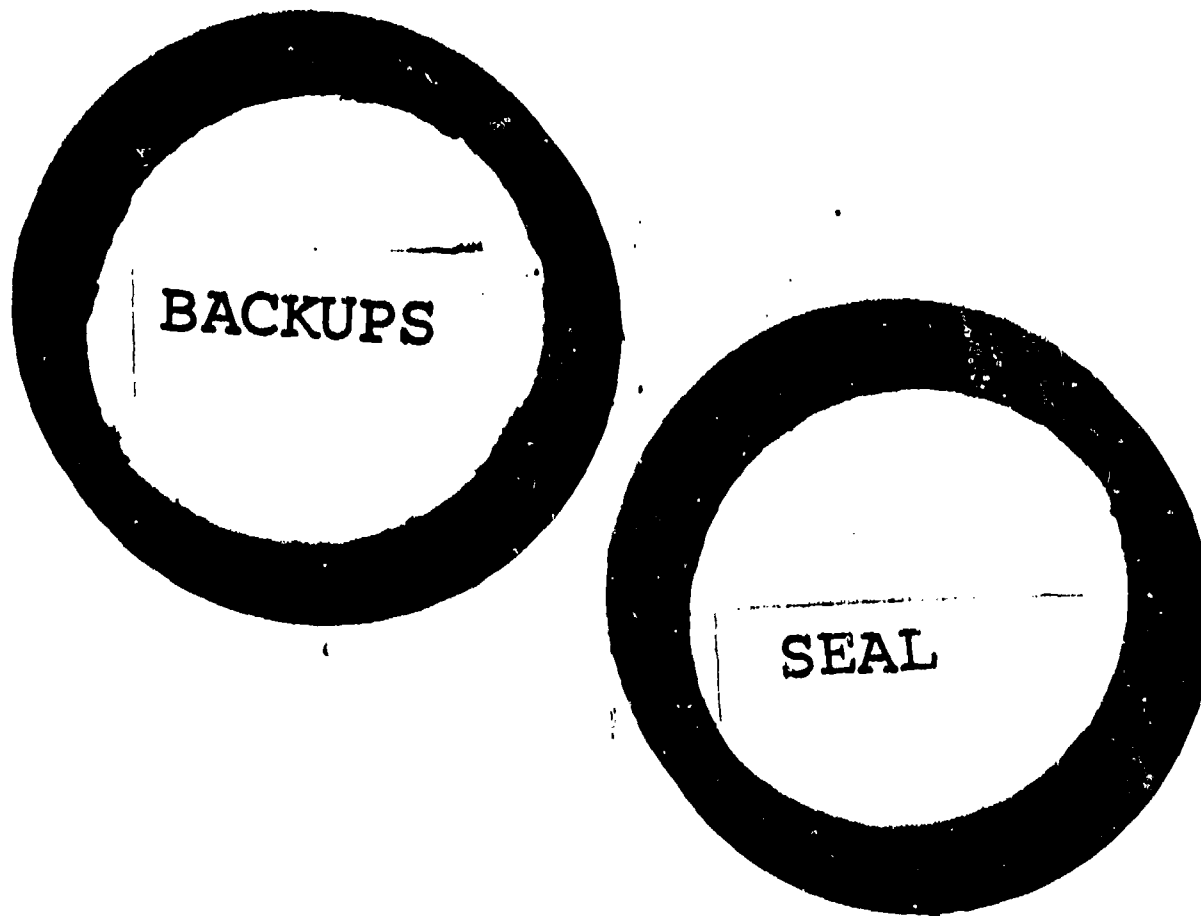
RS29-8R-RS

RESULTS: See Figure 120. The seal and backup were in good condition. Zero dynamic, zero static, and zero low temperature leakage were measured. The rod exhibited a light wear pattern under the backup contact area. The seal had a small crack around the ID on the edge next to the backup.

Figure 120. Candidate RS29 After Single Stage Rod Seal Screening Test. Two stage Revonoc 18158 backups with square cross section elastomer.
